Troubleshooting Guide for Tuning Up ShopBot PRS Gantry Tools

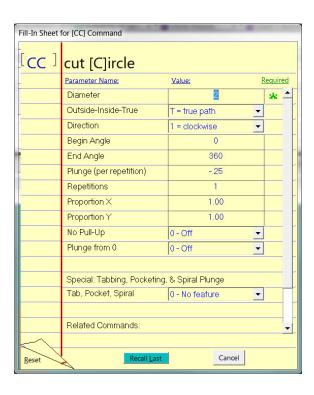
Move the bit over to a location away from the corner where you have experienced issues, or use the location given below. For a full test, use several different locations on the ShopBot table.

M2, 6,6 (Metric: M2, 150,150)

Use the "**CC"** command in the command prompt found in the full version of the ShopBot command software; this will not work in "EASY" mode. This will pull up the window to the left. Fill in the blanks or select the values below.

If the circle cut with the "CC" command is round, but the circle cut from the CAD file is not, look to the CAD file for the problem.

See the "Command Reference" found under "Help" in the ShopBot control software for more details on the "Cut Circle" command.

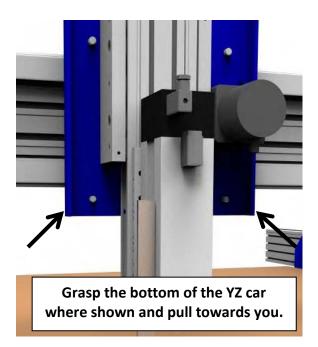
The bottom rollers on the YZ car may be not engaged correctly with the rail on the Y cross beam. This is highly likely if the direction in which the bad cut occurs is consistent.

Test

Grasp the bottom of the YZ car with both hands and pull towards you.

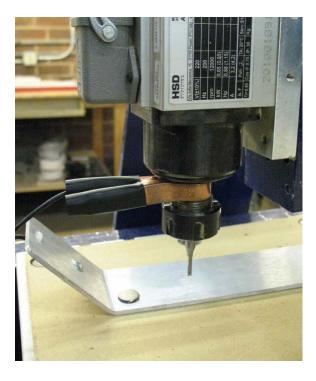
First test: Is the value of plate used in the Z zero routine correct?

- Move the Z over an open area of the table.
- Run the Z zero routine using the Z zero plate. You can use the C2 command or the quick button on ShopBot 3 as shown to the left.
- Remove the alligator clip and store the plate.
- Enter the command "MZ, 0" into the command line which will plunge the bit to the top of the table.
- Test whether the bit is really sitting at the top of the table by trying to slip a piece of paper or card stock under the bit.
 - If the paper won't slide under the bit, the value of the thickness of the plate is correct.
 - If the bit is too high or low, you will need to correct the value of the thickness of the plate used in the Z-zero routine.

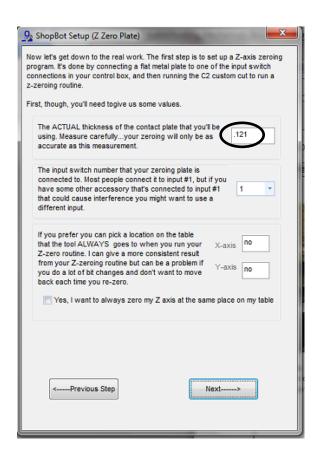
Solution

Inspect your plate to ensure it is not warped or damaged, then measure the thickness of the Z zero plate with calipers. Be as accurate as possible as this will increase the accuracy of your machine.

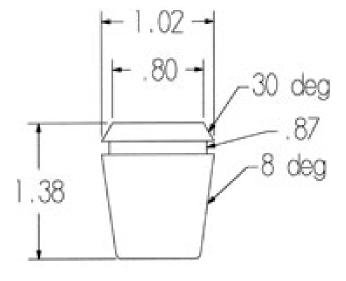
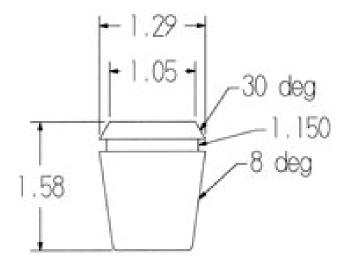
Collet types used by ShopBot and their specifications (in inches)

ER 32 - Automatic Tool Changer (ATC)

Porter Cable collets are only sold in one piece and must be replaced in their entirety.

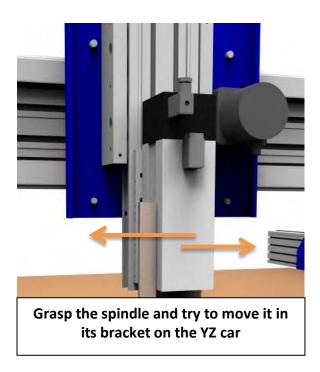
Checking spindle bracket

Test

Check to see if spindle is tightened correctly in its bracket.

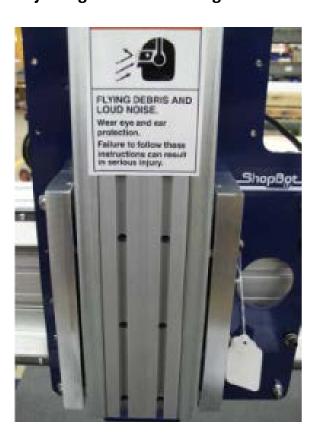
Adjusting the Z car bearings

Refer to the document on the website for information if you need to adjust the bearings on the Z axis.

Signs bearings are too loose:

- Z axis loses steps/position, binds or even stops abruptly.
- There is premature wear to the inner part of the captured rail.

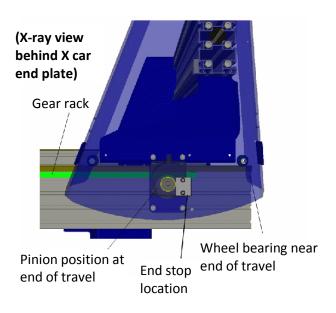
Squaring your tool using end stops

If the end stops were properly set up during tool installation, then they will be squared to each other. In this case you can then use them to pull the gantry into square before you engage the motors/drivers. The motors will hold the gantry in place as long as they are engaged and powered. This misalignment typically occurs when someone moves one side of the gantry while the tool is powered off by leaning or bumping into it. It is recommended to align the motors to each other before every startup.
